REPORT ON THE STRUCTURAL FAILURE OF THE PALACE HOTEL 75 Victoria Street West, Auckland

1.0 Introduction

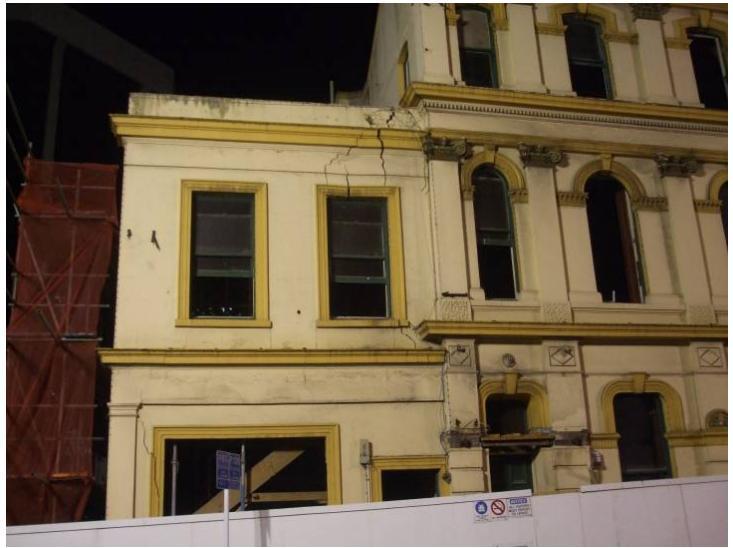
Figure 3

At approximately two o'clock on Thursday afternoon 18 November 2010 [timings vary depending on the witnesses] members of the owner's project team reported becoming aware of large cracks developing on an internal wall on the Federal Street annex. Immediate inspection of the outside facade of this annex, revealed additional cracking occurring in the masonry walls [Figure 3]. Staff noted that the cracks were continuing to open and became immediately concerned for the safety of workers on site. All staff on the site were alerted and the site was evacuated.

The area was cordoned off to all pedestrian and vehicular traffic from approximately 4.30pm. The occupants of buildings from 51-71 Victoria Street were evacuated; likewise, the occupants of a residential unit at 66 Victoria Street. A monitoring regime was established on the Palace Hotel using digital survey equipment to track its continuous movement. The hotel was found to have rotated and was continuing to move at approximately 5mm per hour in a southerly direction towards Victoria Street and number 71 Victoria Street. This movement opened a gap with the Federal Street annexe [Figure 3].

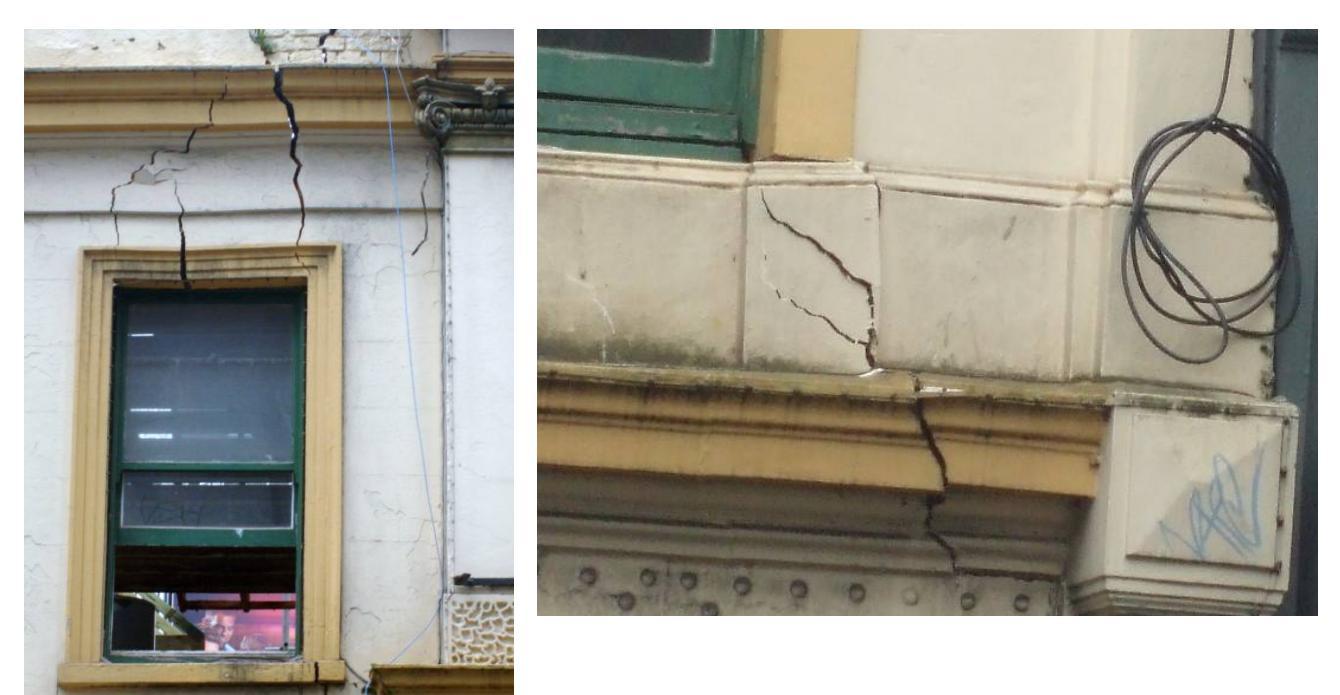
Figure 4

Over the next ten minutes, witnesses reported that the building subsided towards the southeastern side of the site accompanied by substantive deformation of the northern facade [Figure 4] together with cracking to the masonry walls [Figure 5] extending across to the Victoria Street annex.

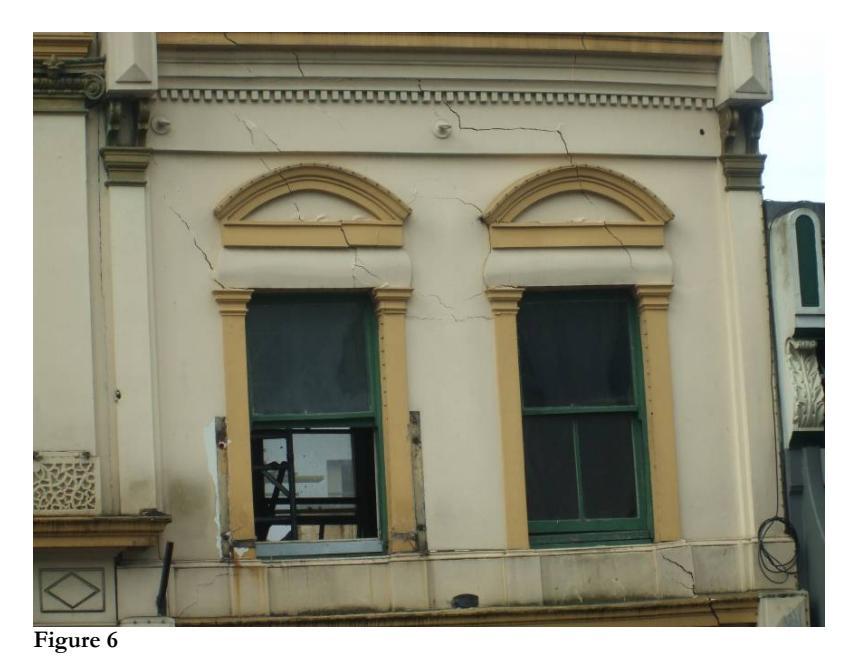
Council staff inspected the site on arrival. We observed that some localised settlement had occurred at the front corner with the Victoria Street annexe causing heavy cracking to the boundary wall from ground to first floor level [Figure 6].

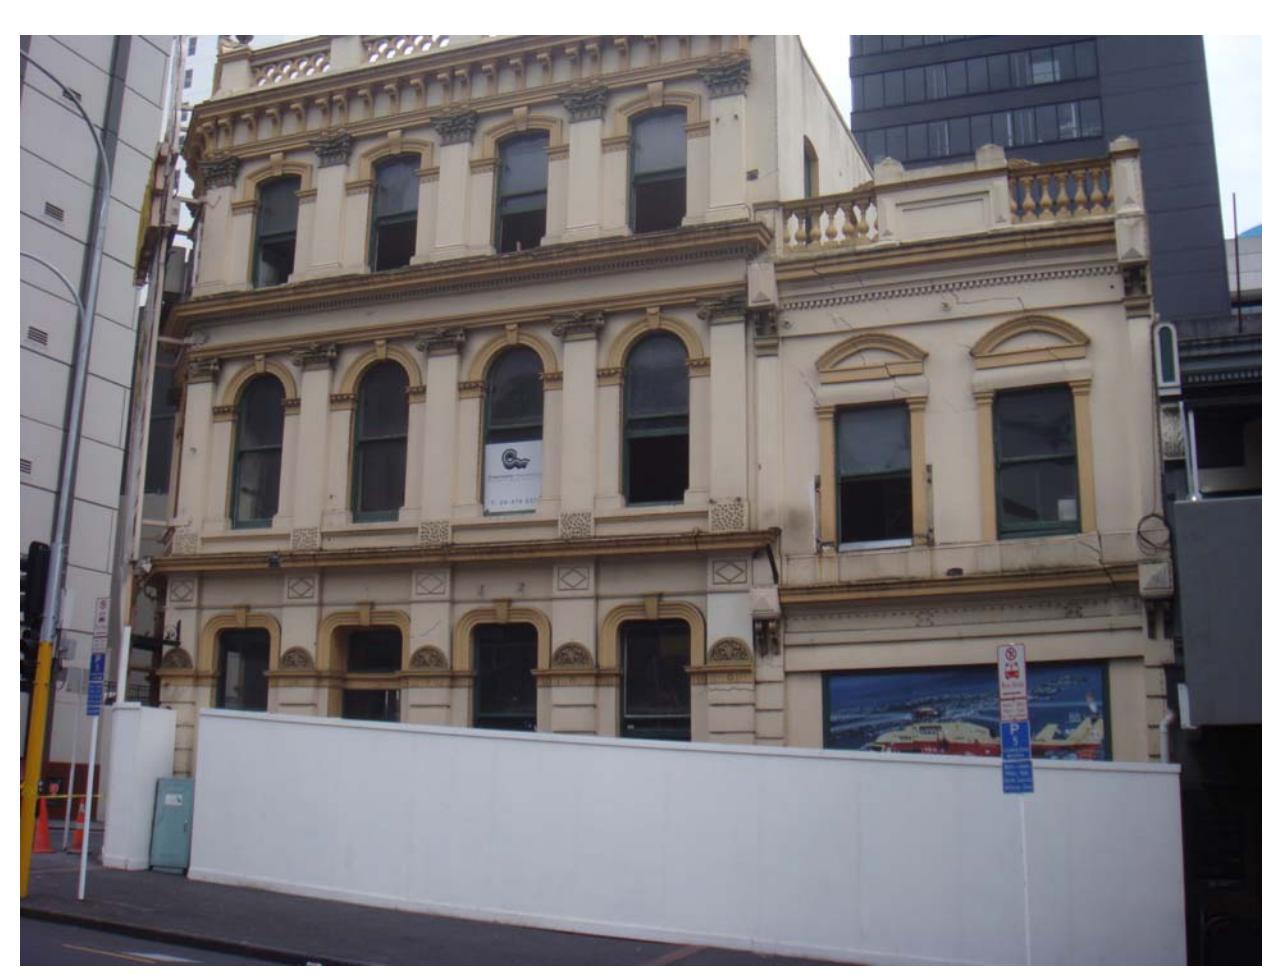
The annexe at this end showed signs of differential settlement as a result of the movement of the main building [Figure 7].

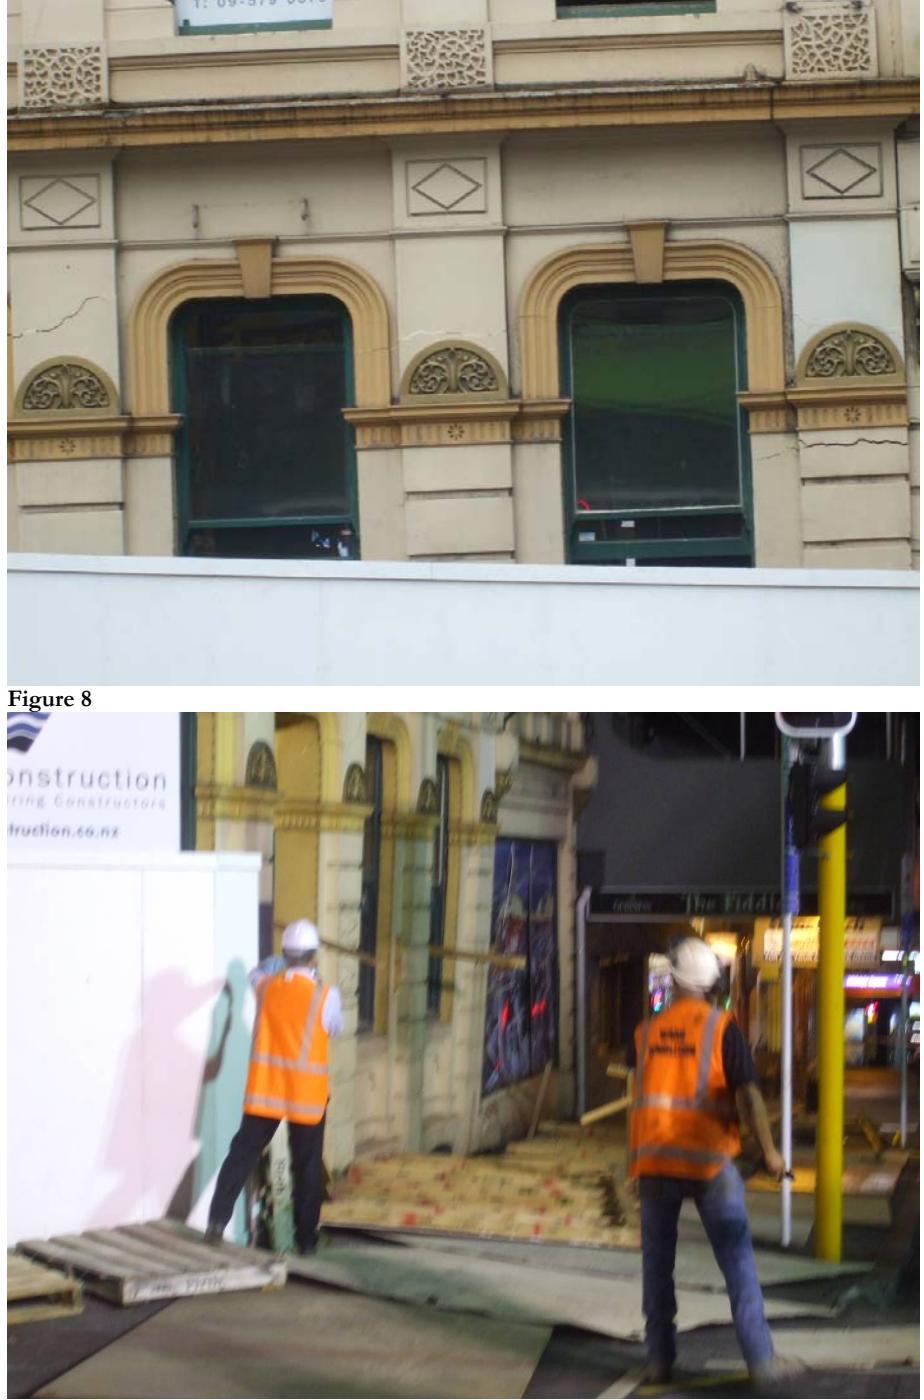
Figure 9

The surveyor advised that the building boundary wall on Victoria Street was approximately 90mm out of plumb (with the top of the wall leaning out over the footpath) [Figure 9]. The wall on Federal Street was out of plumb by about 50mm and both were still moving. During the time it was being measured, there was no sign of settling. There was also a noticeable 'bow' in the front wall on Victoria Street with horizontal cracking around nearby pilasters [structural columns] that became wider as the evening progressed [Figure 8 and 9].

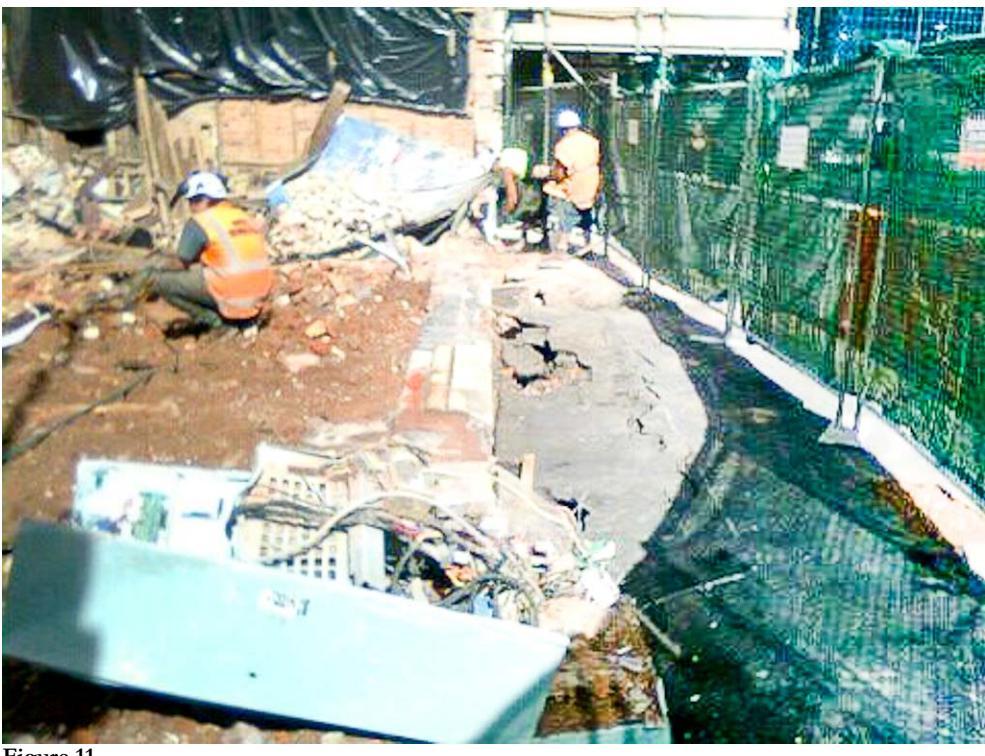
Figure 11

On 10 December, debris covering the Victoria Street footpath was removed uncovering evidence of slumping on the pavement [Refer Figure 11].

Watercare engineers were requested to attend at the site to examine this new evidence. They expressed concern over the risk this slumping posed for their 375 mm diameter water main. As a result, the pipe adjacent to the site was temporarily disconnected from the network. Shortly thereafter, when Council was satisfied that all the immediate risks to public safety had been averted, the site was handed back to the Chow Group.

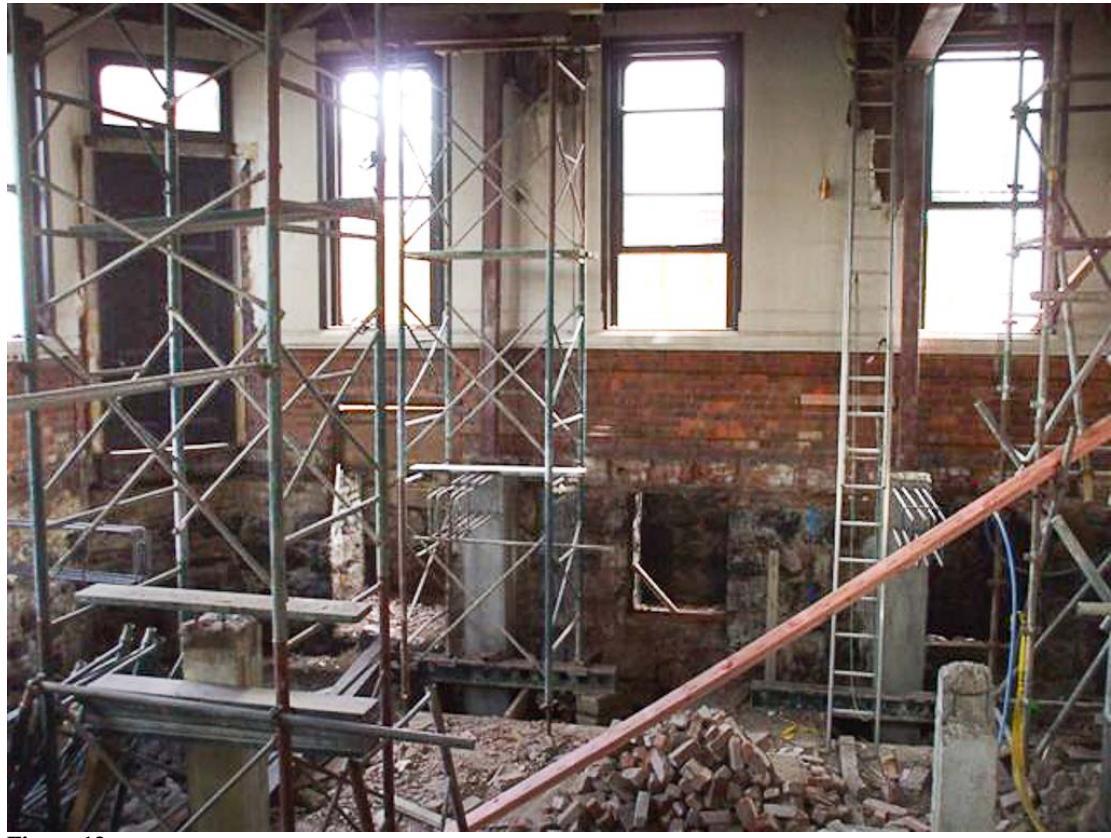
Figure 13

On 8 October, the construction team made a booking for the inspection of an internal gutter in the basement. The attending inspector took a photograph of the basement, refer Figure 13. The wall in the background of the photograph is the basement wall facing Federal Street. There is a marked absence of propping on this wall.

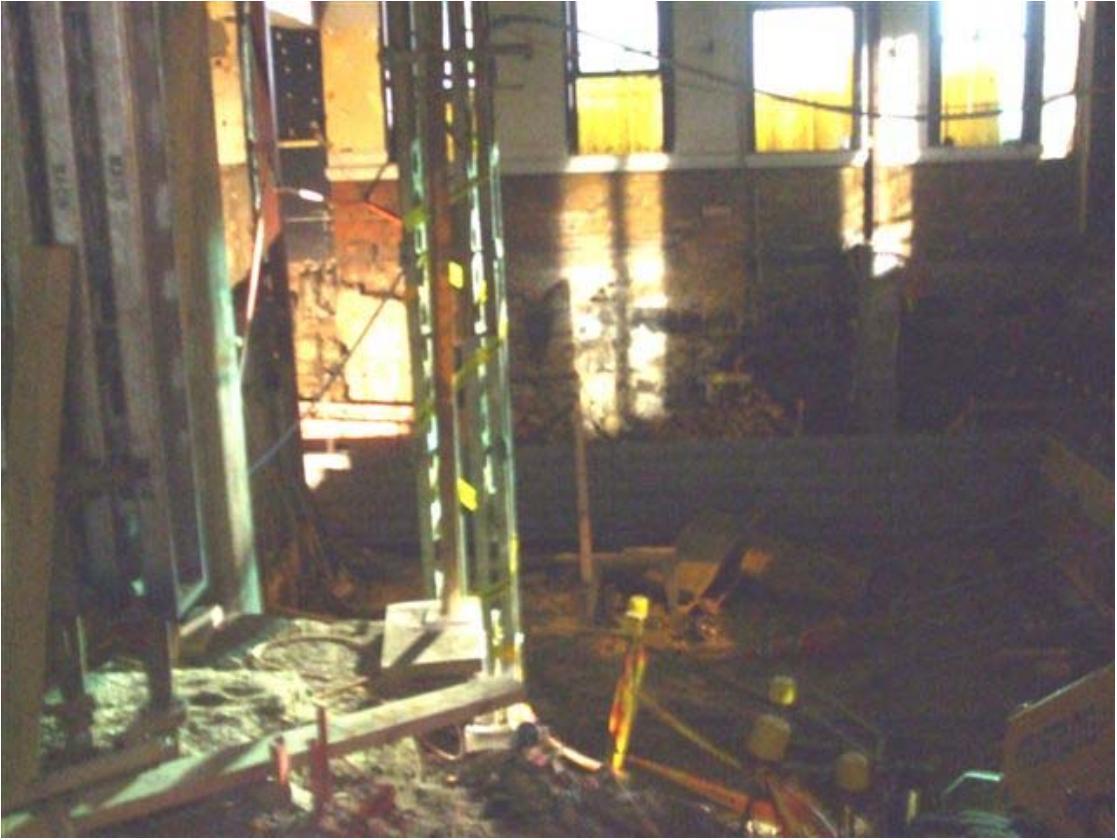
Figure 14

17 November 2010, Council carried out another requested inspection in the basement area, in the area where the failure is believed to have occurred. The inspection was booked for the inspection and approval of a new foundation block-work [several courses of bricks which may seen in the foreground on Figure 14] before it could be filled with concrete. The inspector arrived on site and was subsequently directed to the basement where the subcontractor responsible for the foundations in question, was working.

In the vicinity of the new basement block-work (not visible in Figure 14) was an existing internal wall. The foundations of this wall were found to have been excavated over a two-metre length, in such a manner as to remove support and leave the foundations resting on a number of clay pillars [the rest of the clay underneath having been removed to the level of the new excavated floor level].

The officer was sufficiently concerned by what he saw to request the attendance of the site engineer and amended plans for the works in that area. The engineer was not available and a site instruction was issued citing non-compliance and the inspection 'failed'. The officer instructed that no work was to be undertaken in the area of concern until the site engineer was available to inspect the works and report against the plans.

This finding is consistent with the evidence of the building inspector who attended on 17 November noting the absence of under pinning/and the 'benching' of foundations in this area.

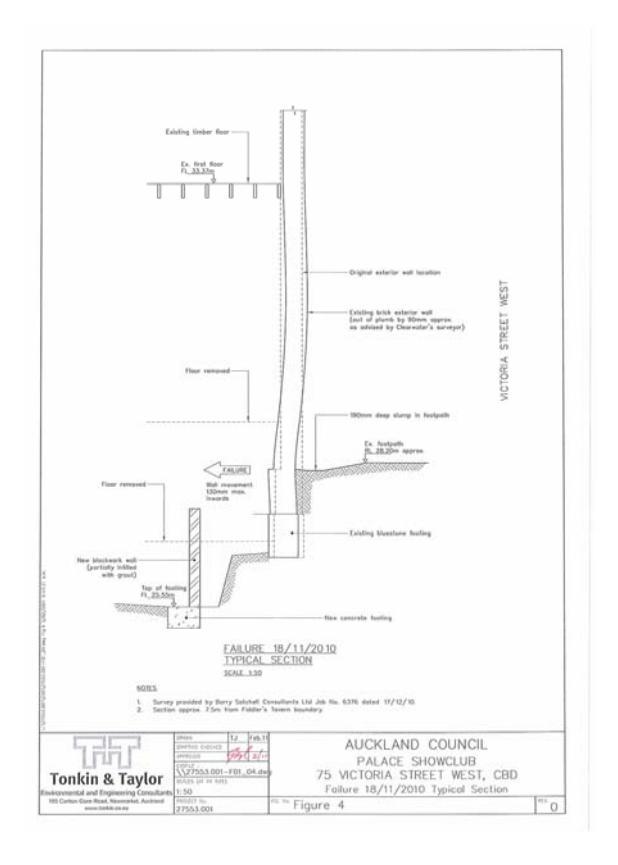
FIGURE 19

Figure 19 Failure depicts the situation when the brick wall collapsed, The wall has no factor of safety against sliding in to the excavation. The resulting deformation of the wall increasing the inherent instability of that wall. The blue stone block moved inwards along with the brickwork above it. This movement has in turn caused a loss of vertical and lateral support to the wall on Victoria Street West. This led to the deformation seen in the rest of the building.

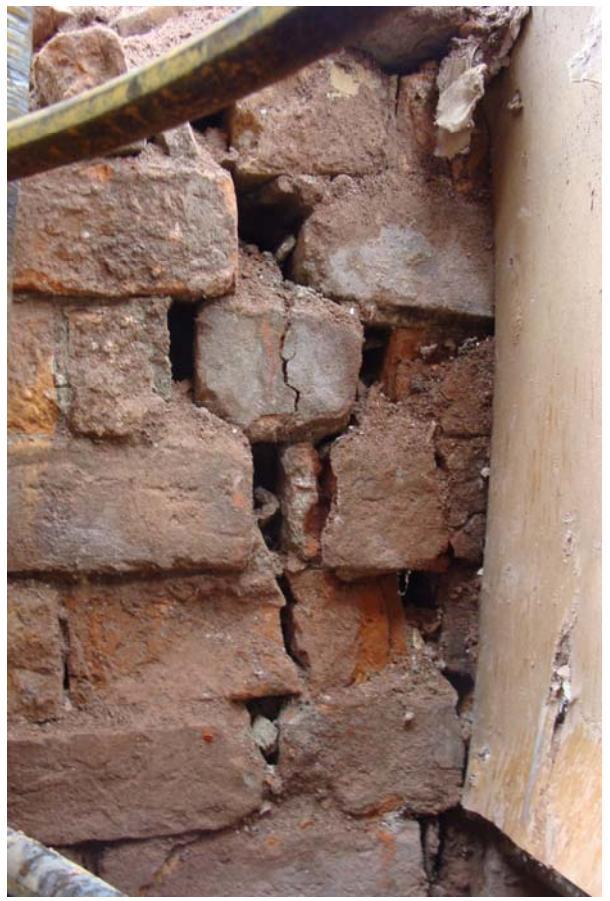
FIGURE 20

Figure 20 Condition of Brickwork presents a view from the basement wall after the failure revealing the effect the failure has had on brick work in the area. When shear forces subjected to many bricks have broken apart and the mortar has given way. This is indicative of low compressive strength of the brick work and the condition of the mortar.

'The hotel is considered to be earthquakes prone. Spencer Holmes assumed relatively high brick and mortar strengths in their design and this was verified by peer review. Testing of the actual bricks in the Federal Street annex revealed significantly weaker values than assumed and recommended testing take place in the main hotel building. This appears not to have been undertaken. We therefore believe that it is highly likely the brick walls were than significantly weaker the designers assumed.' p4 Marriott Consulting Engineers 02/02/2011

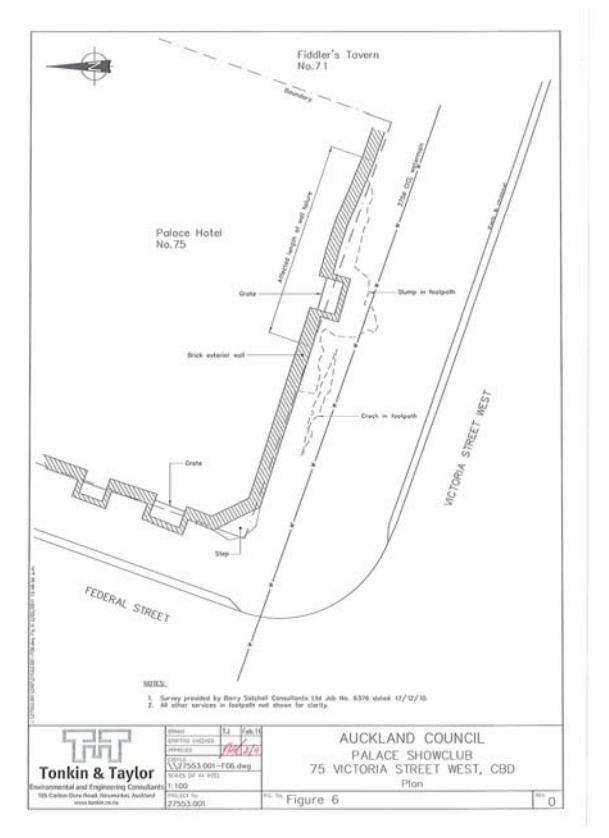
FIGURE 21

Figure 21 Post Failure Boundary Wall shows the basement wall bowed inwards over a 7-metre length along the Victoria Street West boundary.
