# Collapse of a system – the sequence of events

## HMNZS Canterbury

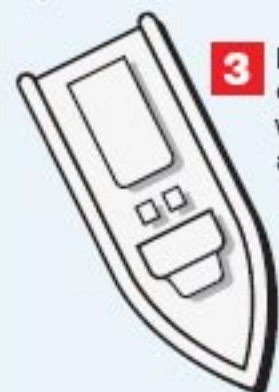
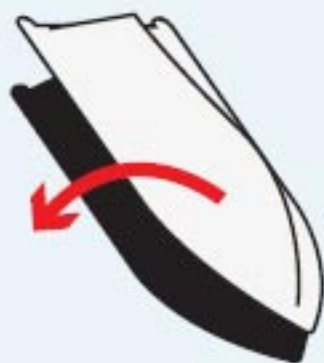
**1** Boat rope keeping Rhib alongside the ship comes free due to unscheduled release of Gibb shackle.

**2** Crew unable to quickly extract O-ring connecting lifting straps to davit hook.

**3** Bow of Rhib veers out due to force of water, broaches and capsizes.

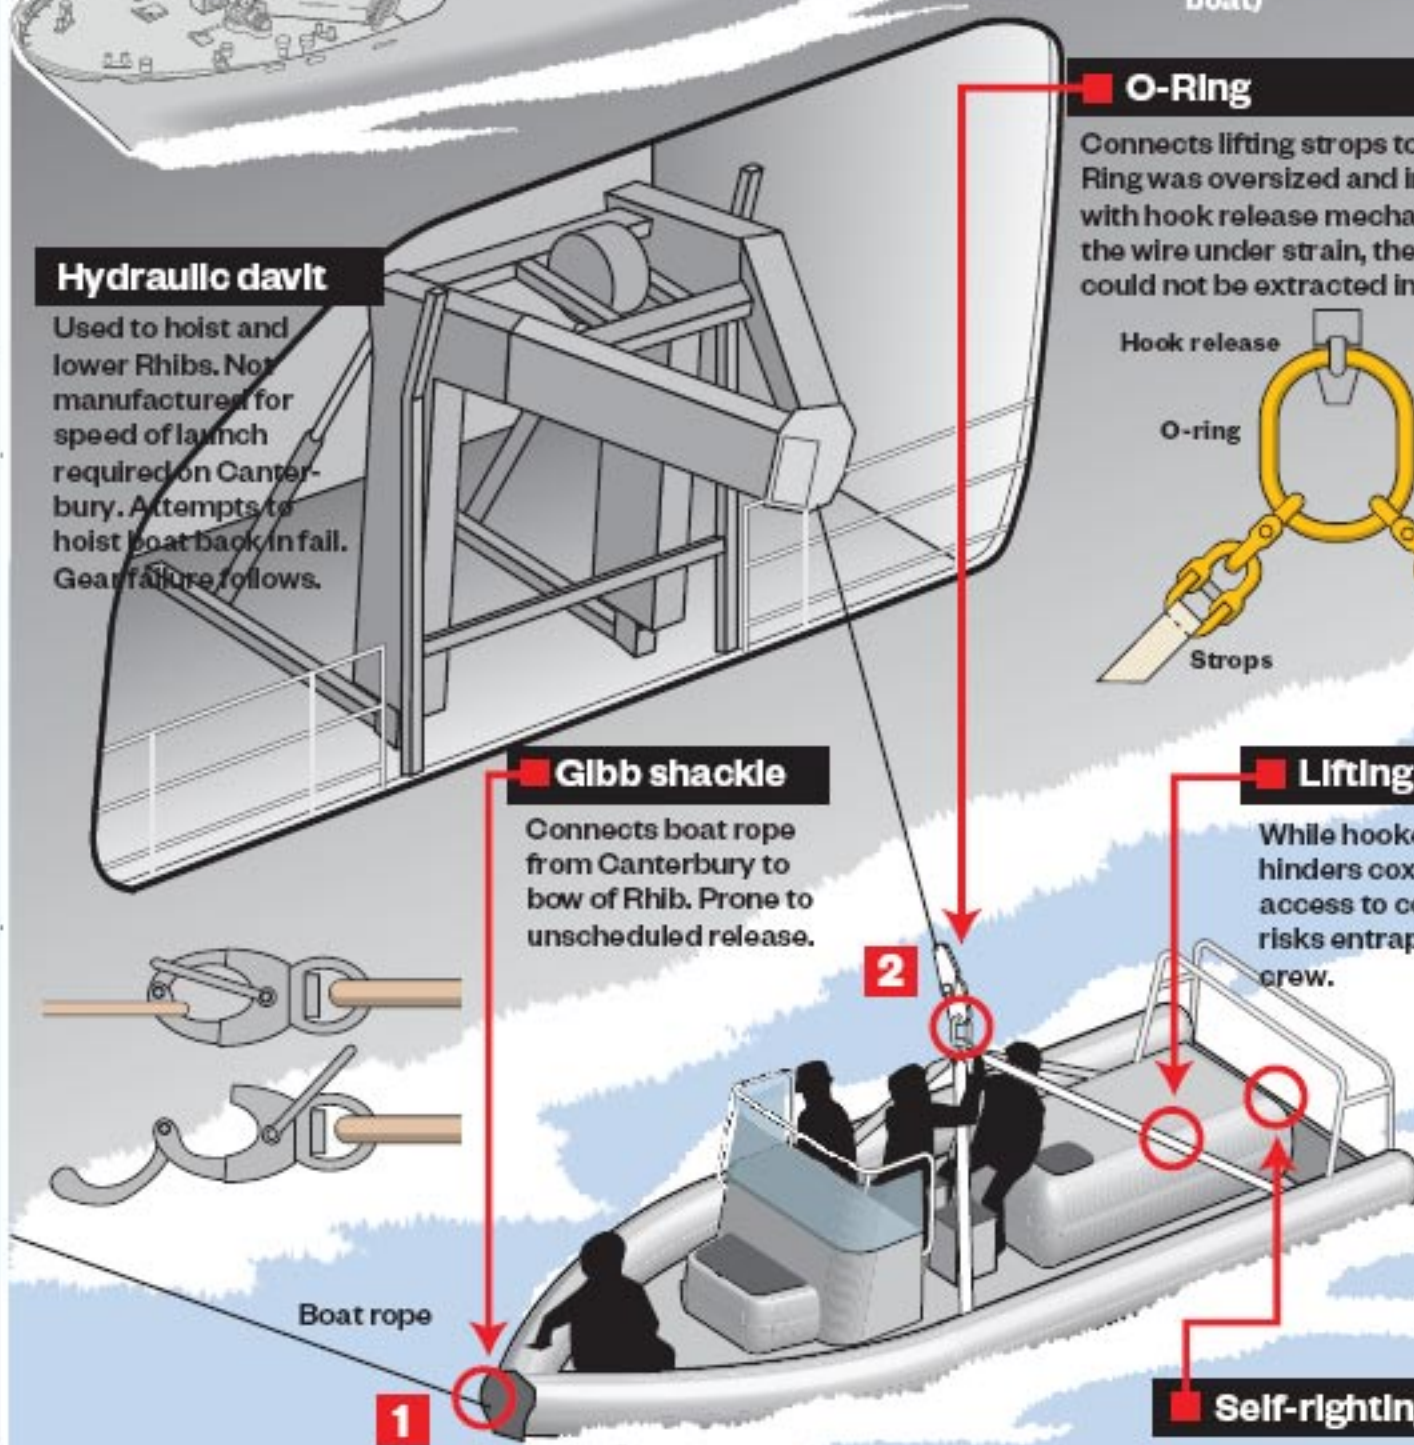
### Lifting straps

While hooked up, hinders coxswain's access to controls and risks entrapment of crew.

### Self-righting device

Failed to activate. Was subject of manufacturer's recall.
