REPORT ON THE STRUCTURAL FAILURE OF THE PALACE HOTEL 75 Victoria Street West, Auckland

1.0 Introduction

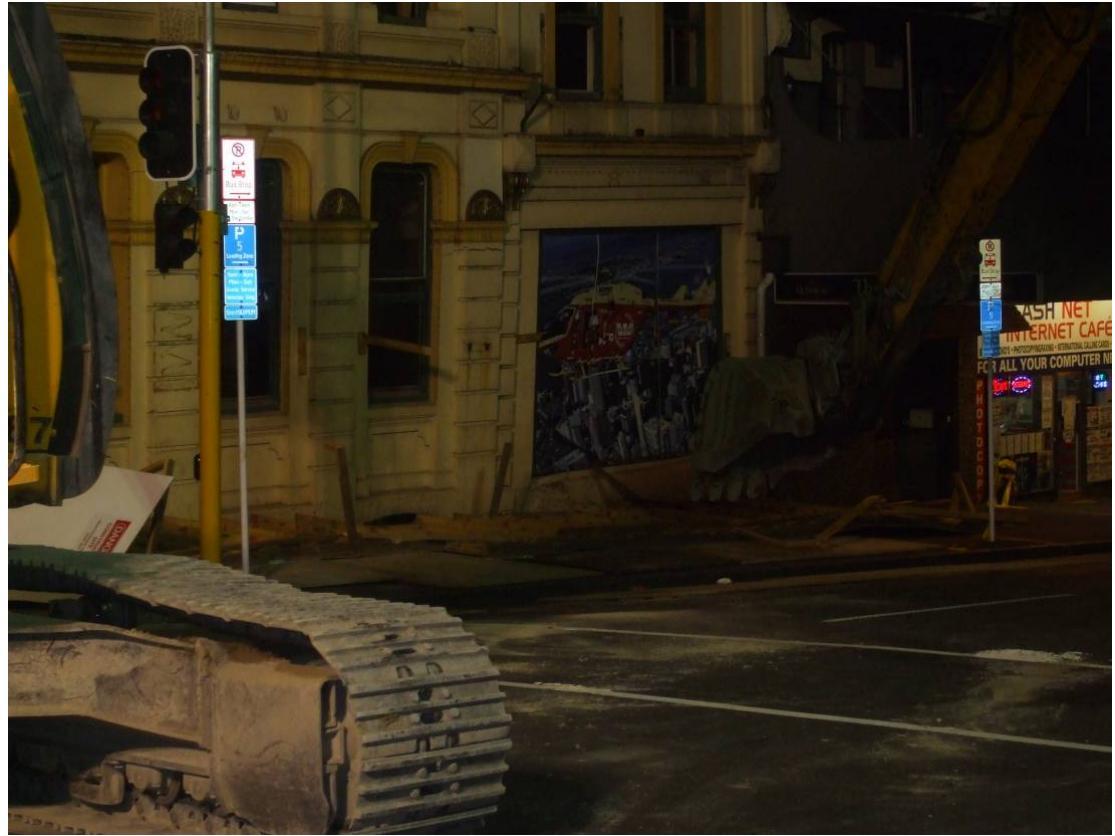
Figure 10

At about 1.00am, demolition was commenced refer Figure 10, concluding at 3.00am. The Council retained control of the site until an inspection could be made the next day to confirm the site was safe. At that subsequent inspection, a number of hazards were identified and arrangements were made in conjunction with Clearwater Construction to have these structures reduced. Council also advised the owners that it would retain possession of the site until the immediate public safety

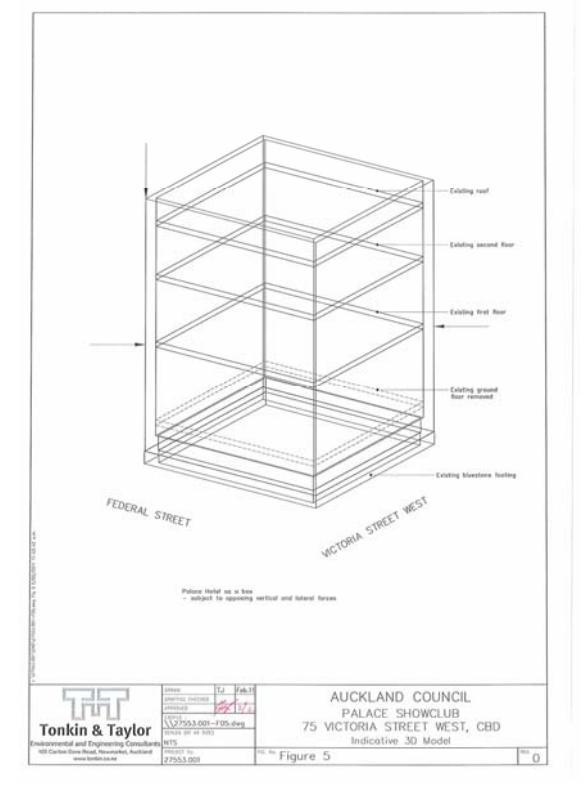
FIGURE 15

Figure 15 Opposing Forces depicts the Palace Hotel as a box-like structure where the walls and floors of the structure all contribute to a greater or lesser extent to the structural integrity of the building. When any one of these elements is removed durina the course of renovation/redevelopment consideration needs to be given to its effect on the integrity overall of the structure. This often requires the insertion of additional supporting elements in the form of props and walls to mitigate or cancel any loss of vertical or lateral support.

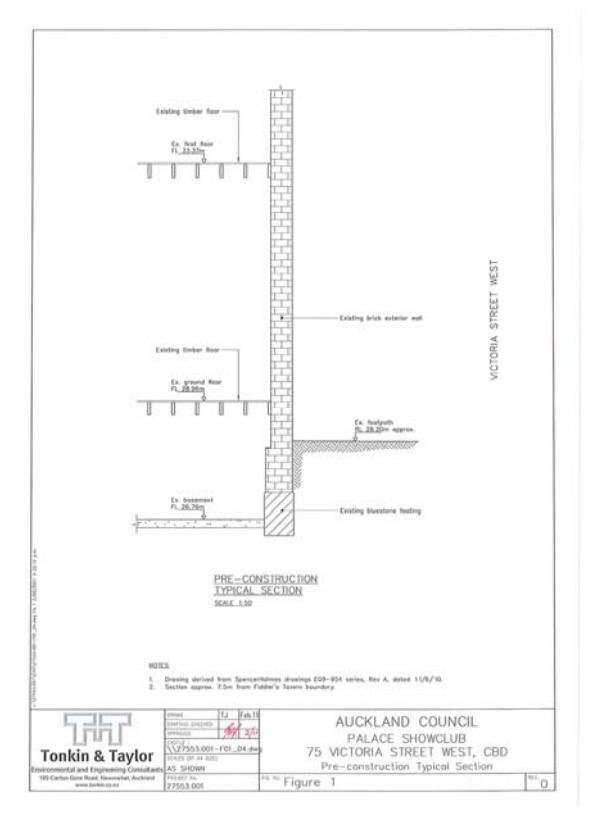
FIGURE 16

Figure 16 Pre-Construction provides a cross-section of the boundary wall with Victoria Street West. The basement wall may be seen to be supporting approximately two meters of road reserve. This force may be seen to be opposed by the ground floor wall and the basement floor which includes a concrete floor topping. The bluestone slabs that form the foundation base of the un-reinforced brick wall may be seen at the base of the bricks.

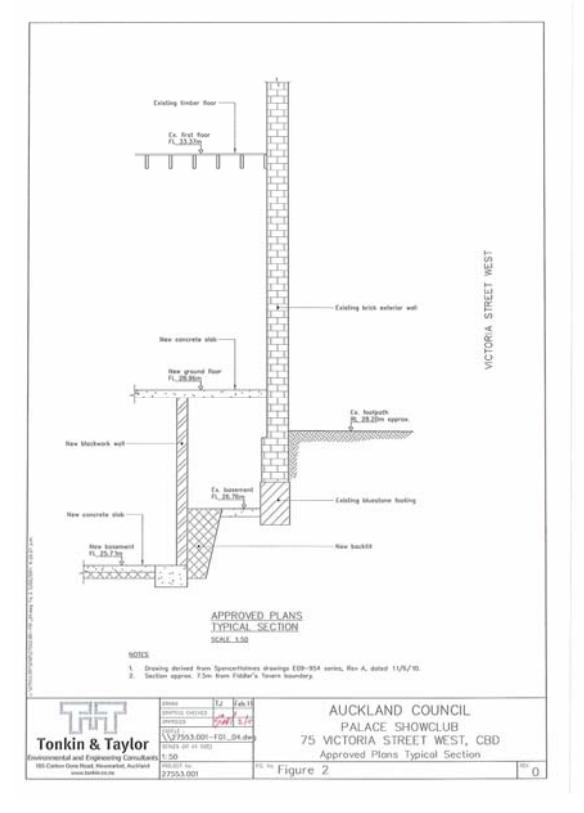
FIGURE 17

The movement of the basement wall foundations is attributed to a loss of lateral support caused by the removal of the timber ground floor, an over excavation of the foundations and the removal of a portion of the existing basement concrete floor designated to be retained in the approved plans [Figure 17]. It was this combination of factors, rather than any of them individually, that caused the building structure to collapse.

Figure 17 Proposed Construction describes the proposed changes to the basement as part of this development. As may be seen, the basement floor was to be excavated approximately а further 1.1 meters. A section of basement floor and concrete topping were to be left at the base of the foundations to provide lateral support. A new ground floor was to be added and a new block wall to be established inside the boundary wall to the top of that new ground floor. The outside of the block was then to be infilled to provide further support to the foundations.

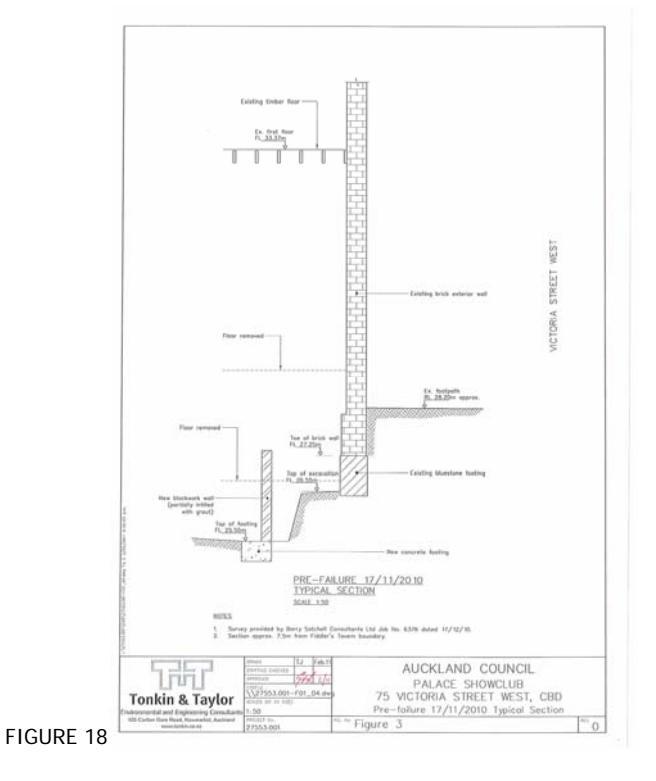
Figure 18 **Pre-Failure** describes the situation along at least some portions of the boundary wall prior to the collapse. As may be seen the around floor has been removed. The foundations have been further exposed and the concrete floor that was proposed to have been retained has been removed. The removal of the basement slab and the ground floor leaves a substantive portion of un-reinforced brick wall subject to pressure from the road reserve. The initial courses of the new block wall have been added but have yet to be backfilled as required in Figure 17.
